Subject: **Milwaukee County Fleet Garage – Condition Assessment Report
10320 W. Watertown Plank Road, Milwaukee, Wisconsin
ZS Project No.: 7523**

The following is a report of the ZS assessment of the main roof systems at the Milwaukee County Fleet Management maintenance and vehicle storage garage in Milwaukee, Wisconsin.

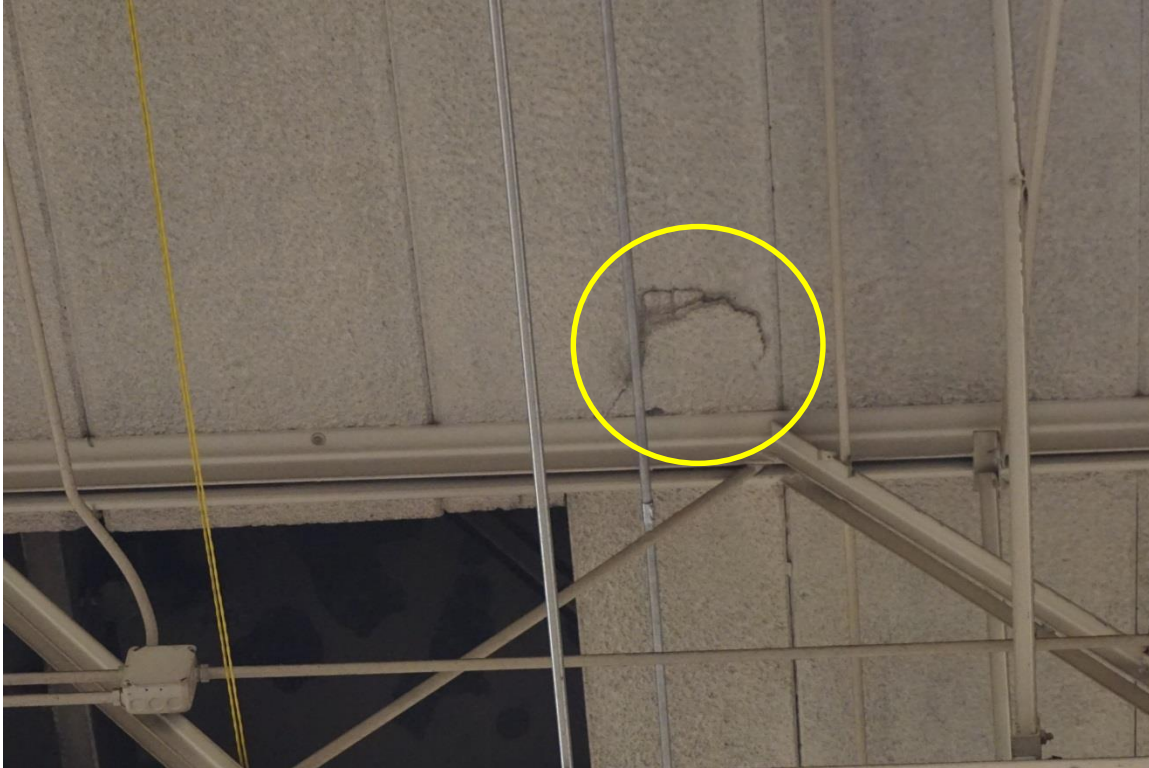
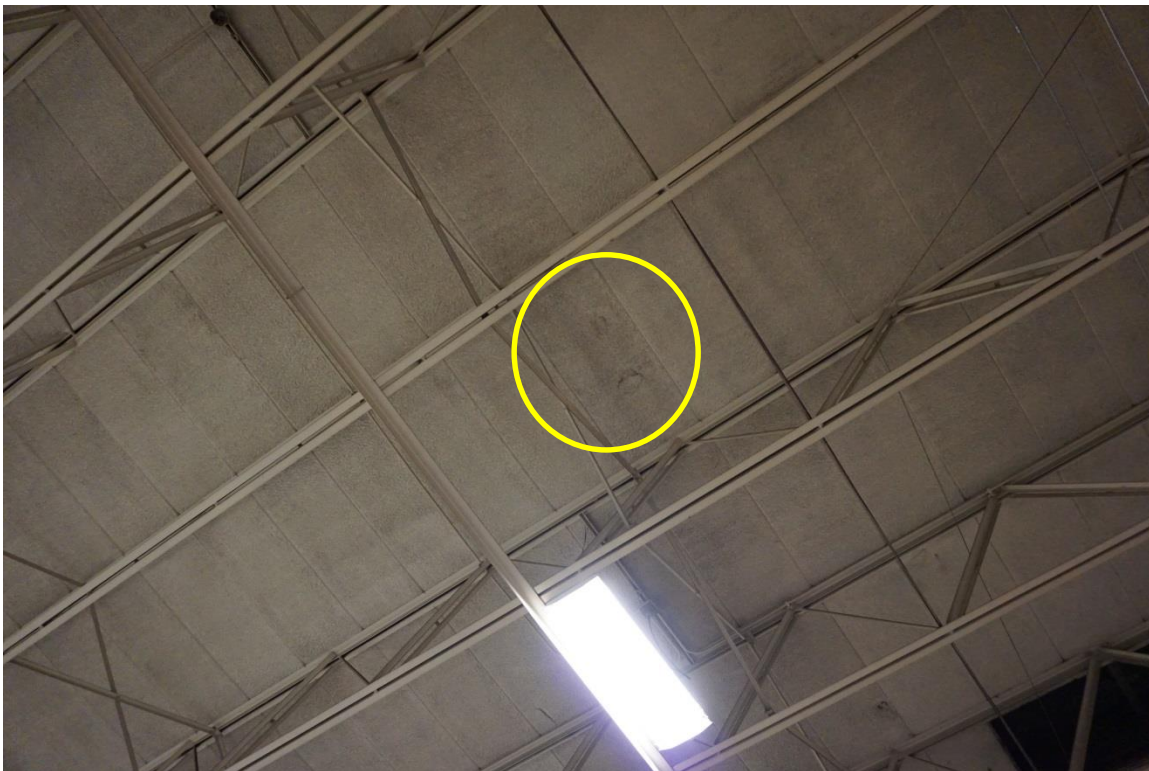
- Water stains and spalling observed on the underside of the Tectum roof deck in the storage area (Figures 1-2).
- Water stains and evidence of leakage was observed on the ceiling of the mezzanine storage area in the southwest corner of the building (Figures 3-4).

Figure 1: Water stain and spalling on roof deck interior.

Figure 2: Water stain and spalling on roof deck interior.

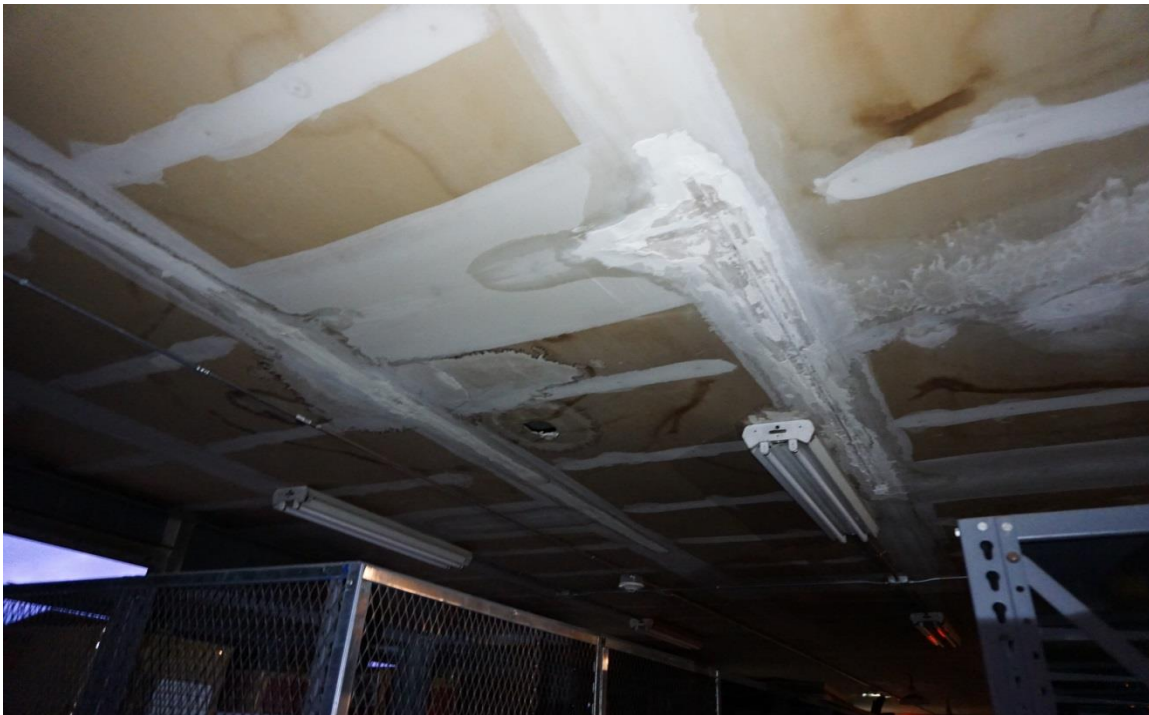
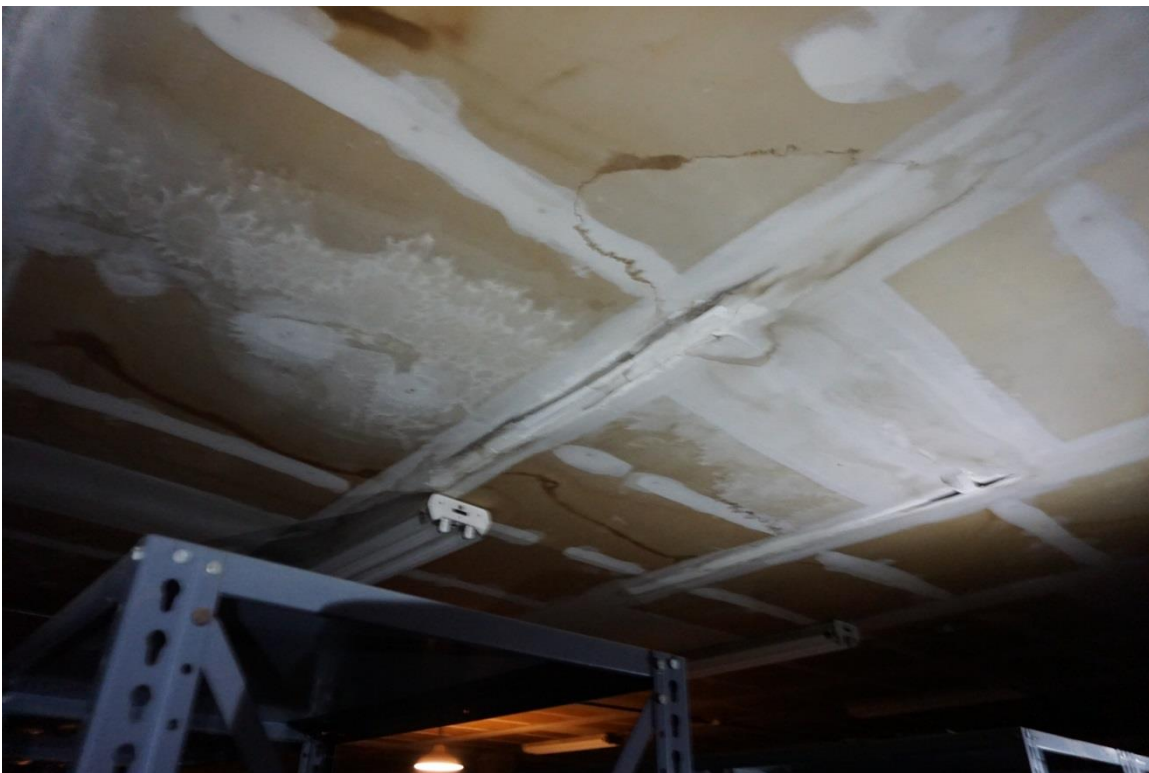
Figure 3: Water stains and leakage in interior ceiling.

Figure 4: Water stains and leakage in interior ceiling.

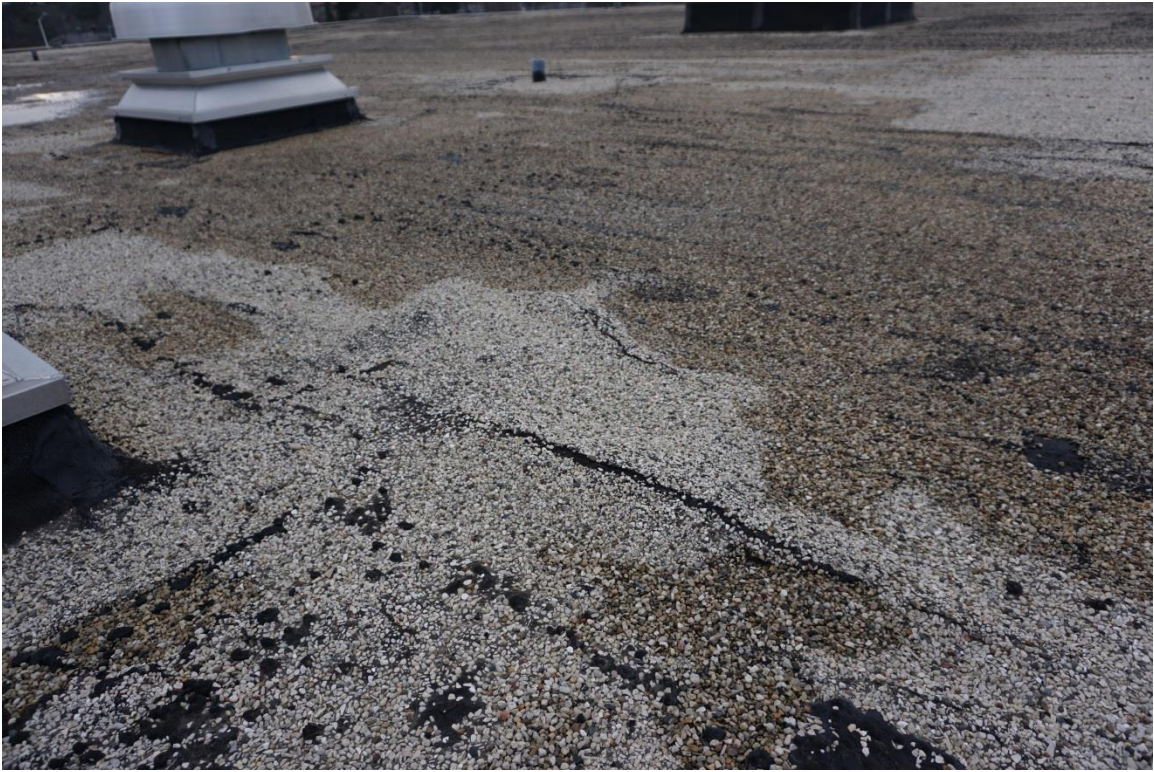
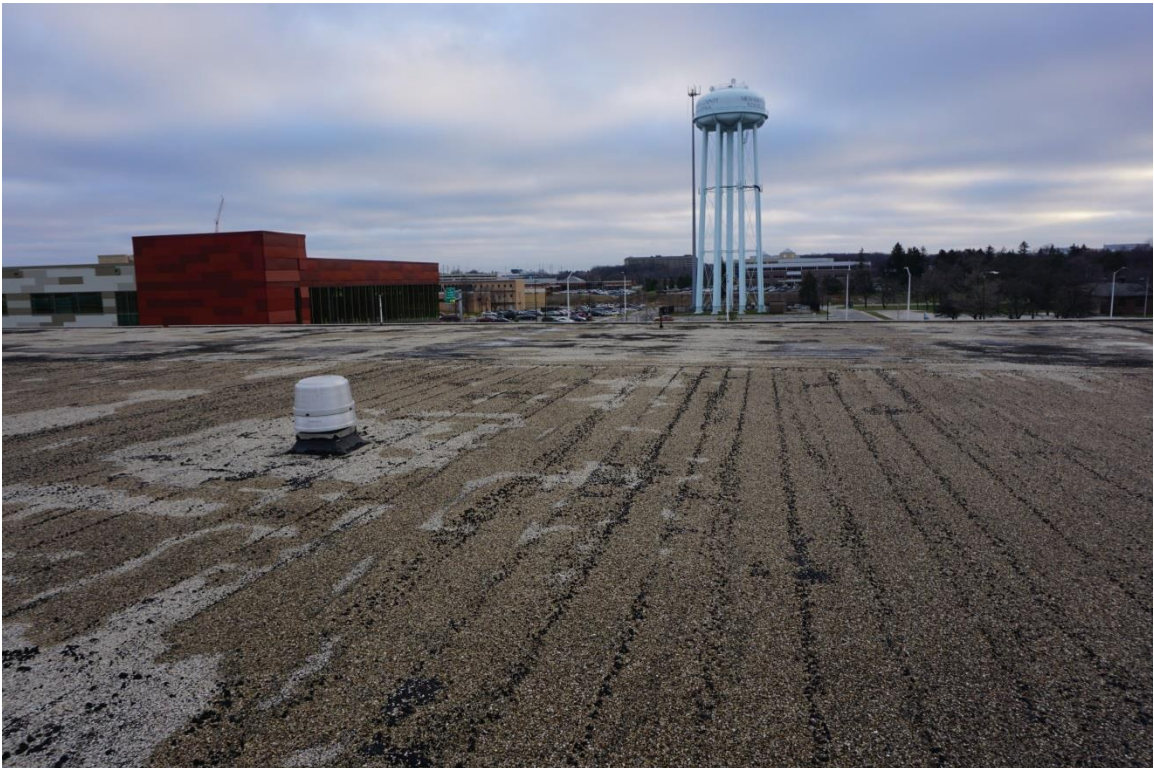
- Numerous moderate to severe blisters were observed in various areas across the entire field of the roof system (Figures 5-6).
- Ponding water was present in various areas across the entire field of the roof system (Figure 7).
- Exposed bitumen displayed severe deterioration including surface cracking and bubbling of the membrane (Figures 8-9).
- Multiple large patches were observed in the roof system (Figures 10-11).
- Large areas of the roof system are missing gravel surfacing and feature exposed bitumen (Figure 12).
- Multiple vent penetrations lack appropriate flashing (Figure 13).
- Multiple roof drain covers were observed either broken or missing (Figure 14).
- Multiple punctures and failure points were observed in the membrane (Figures 15-18)

Figure 5: Blisters in roof membrane.

Figure 6: Blisters in roof membrane.

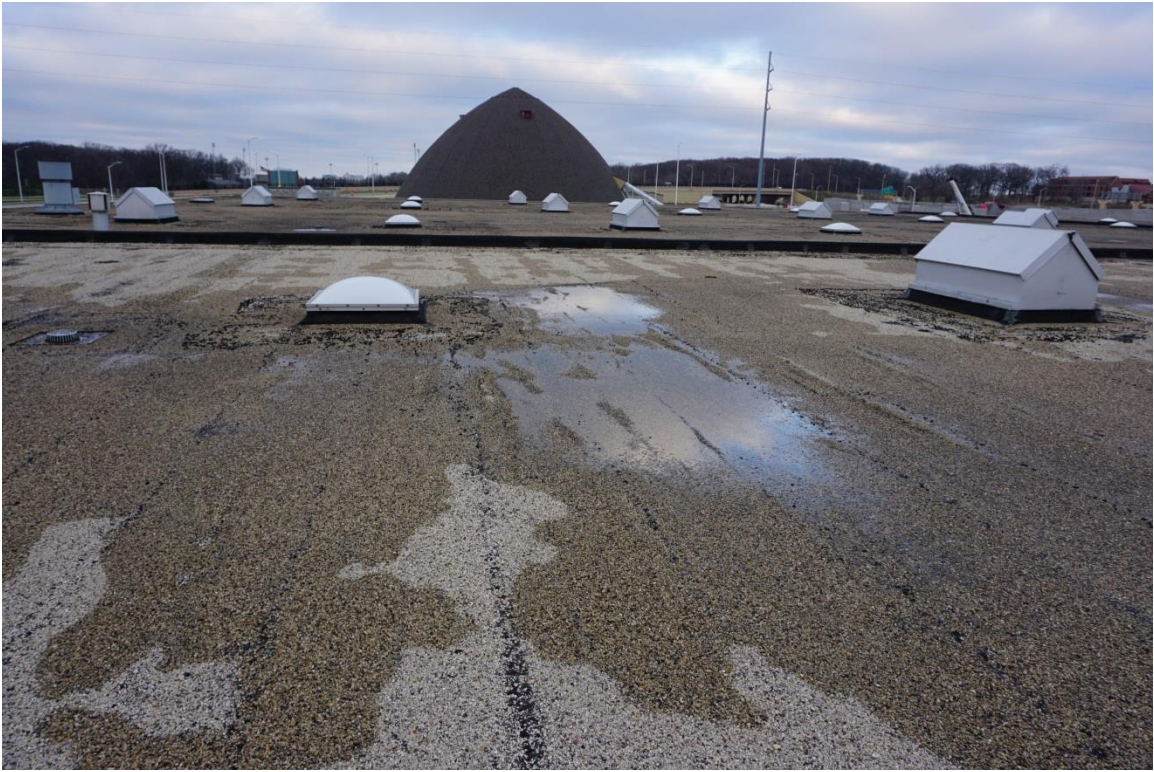
Figure 7: Ponding water.

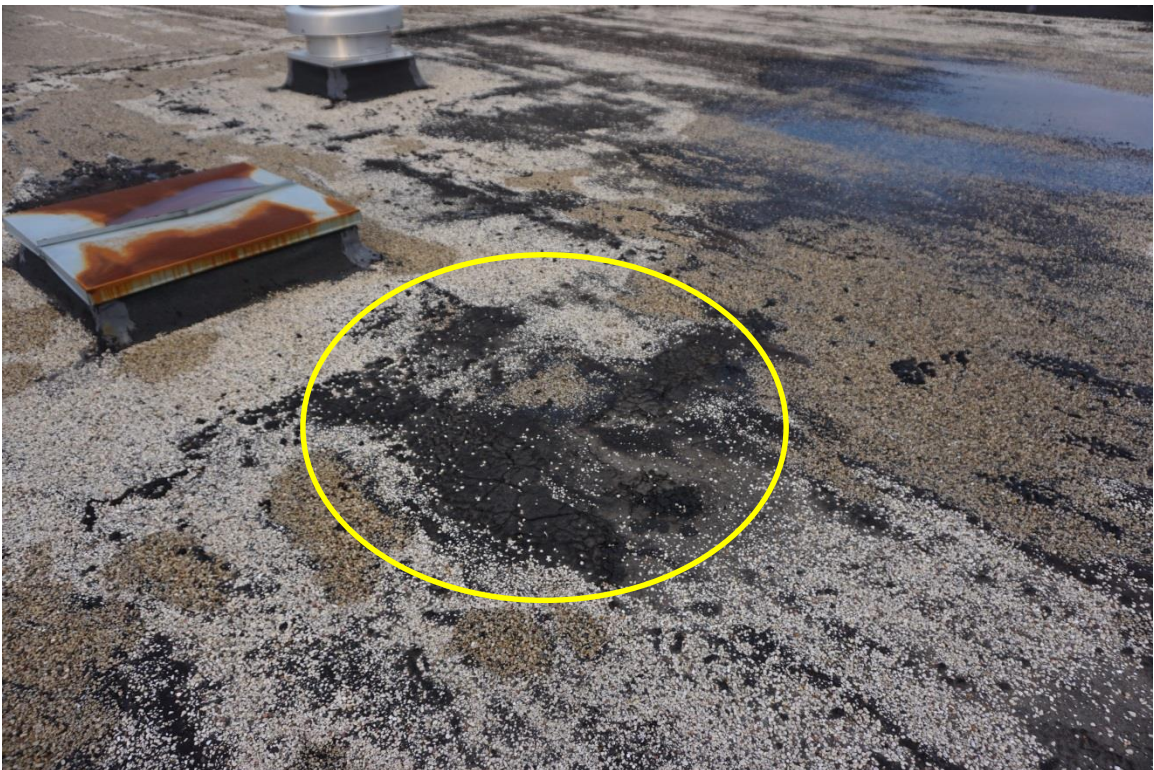
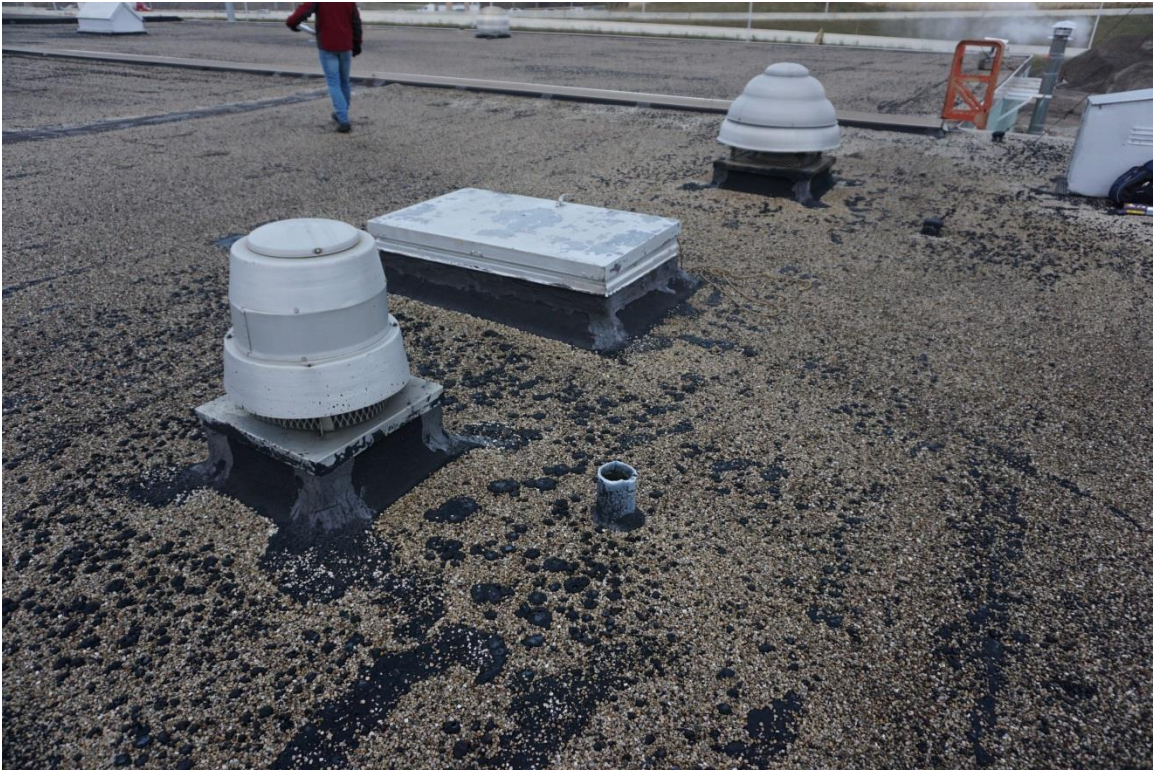
Figure 8: Exposed bitumen.

Figure 9: Exposed bitumen.

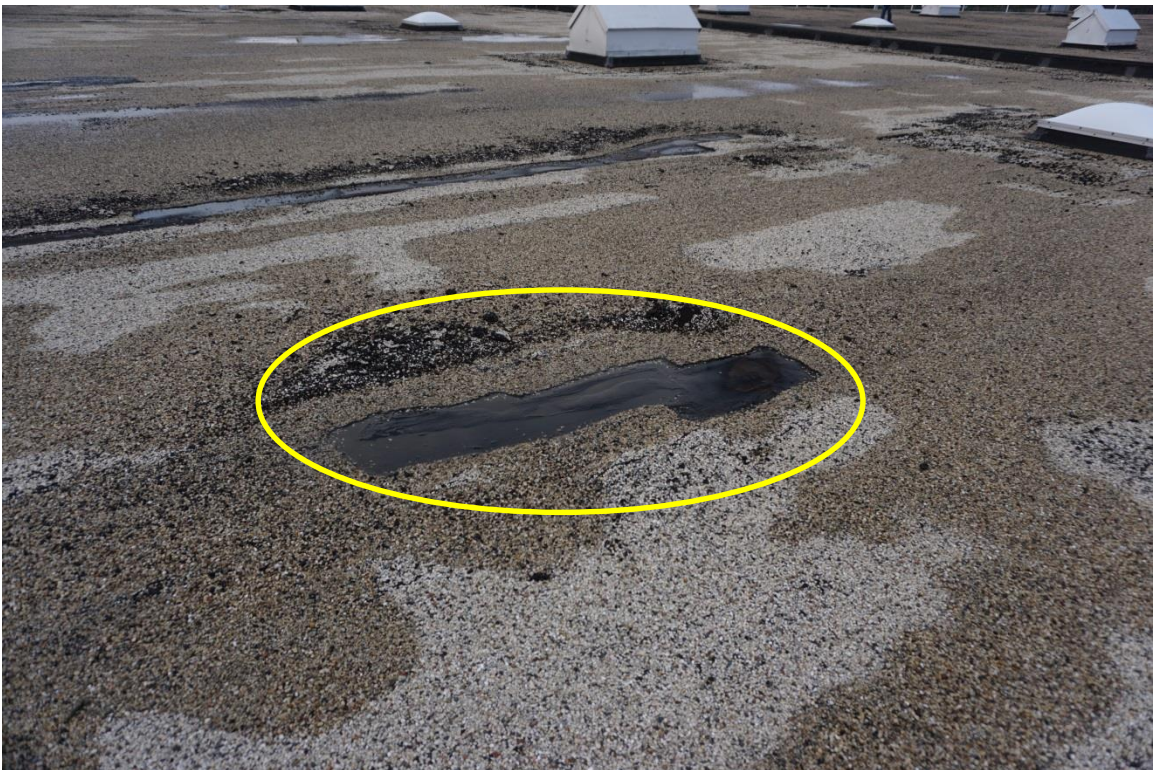
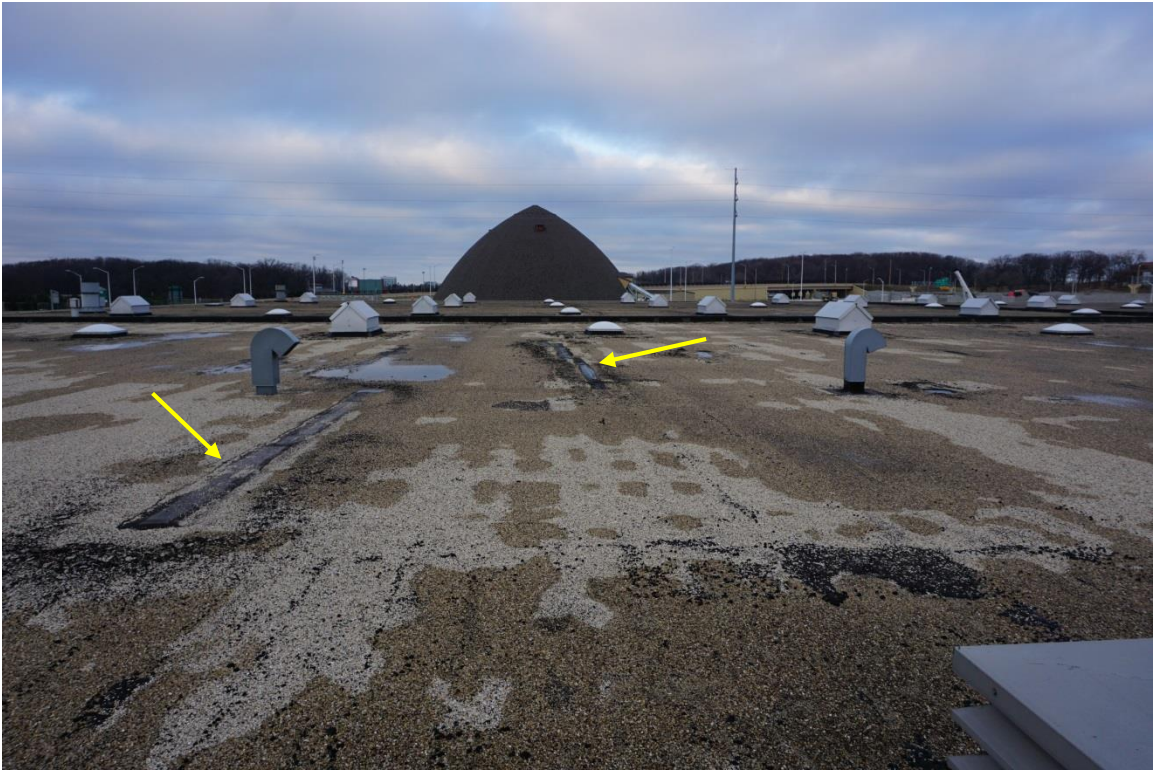
Figure 10: Patches in roof system.

Figure 11: Patches in roof system.

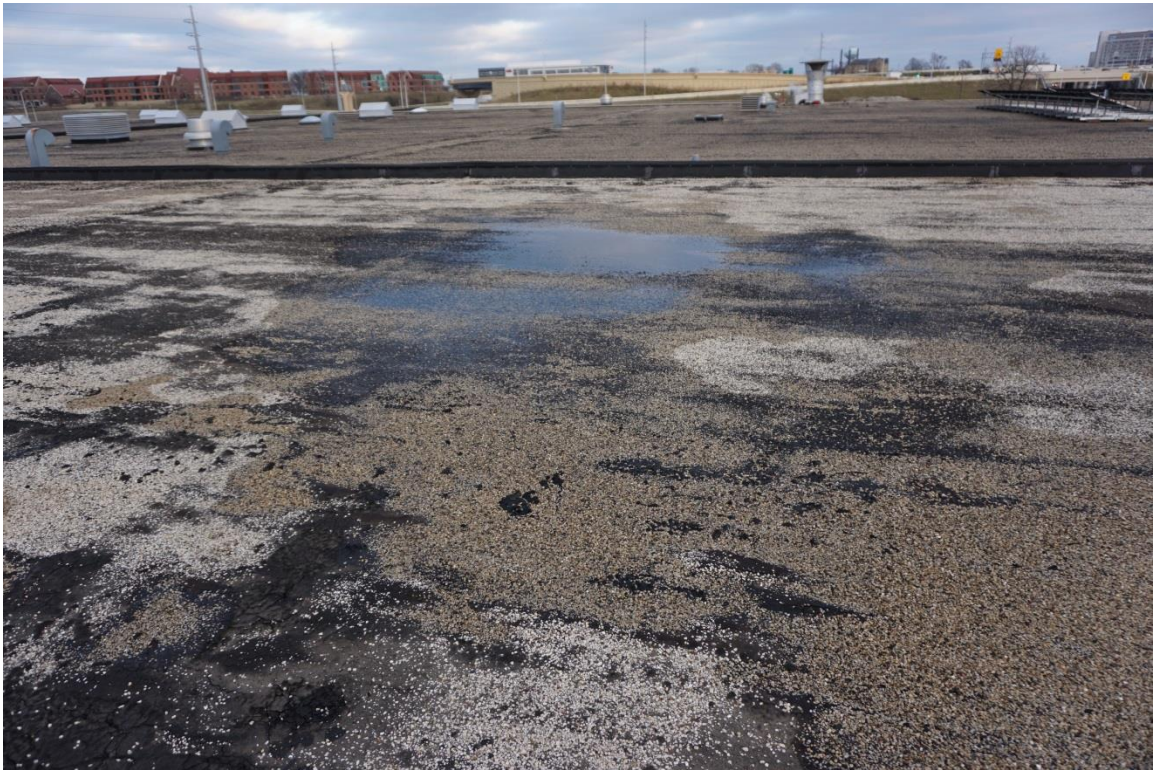
Figure 12: Exposed bitumen and ponding water.

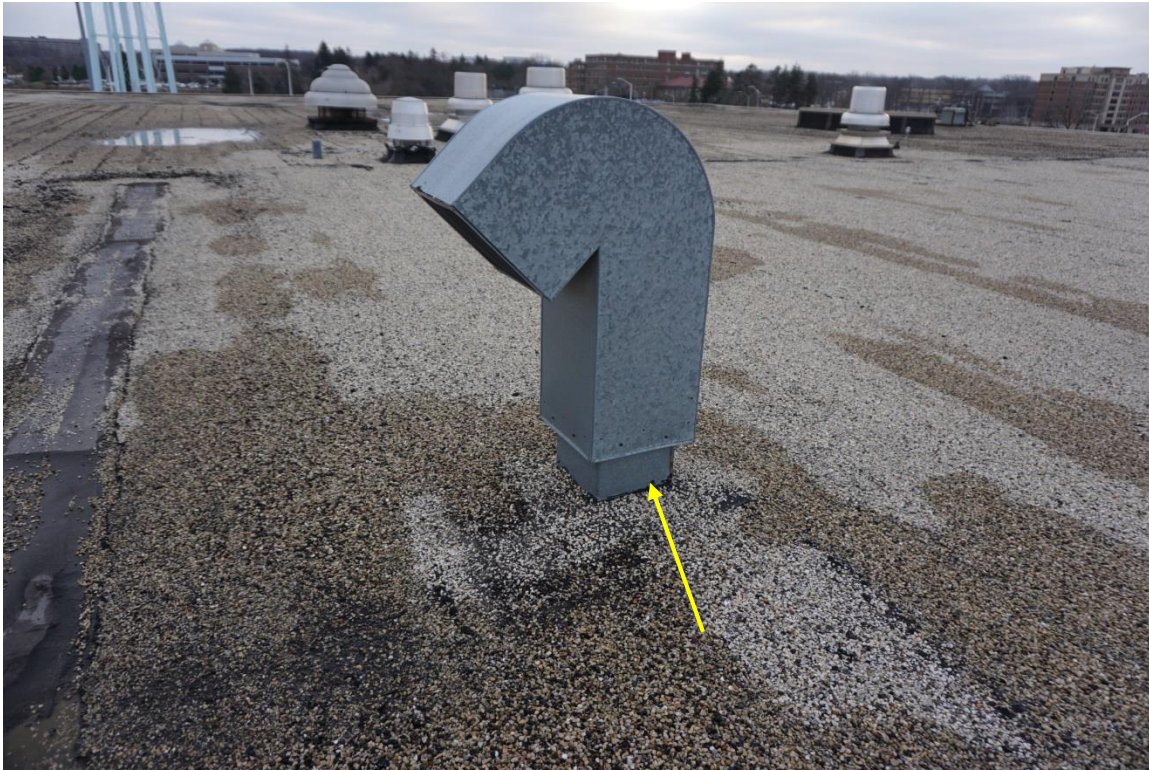
Figure 13: Vent with missing flashing

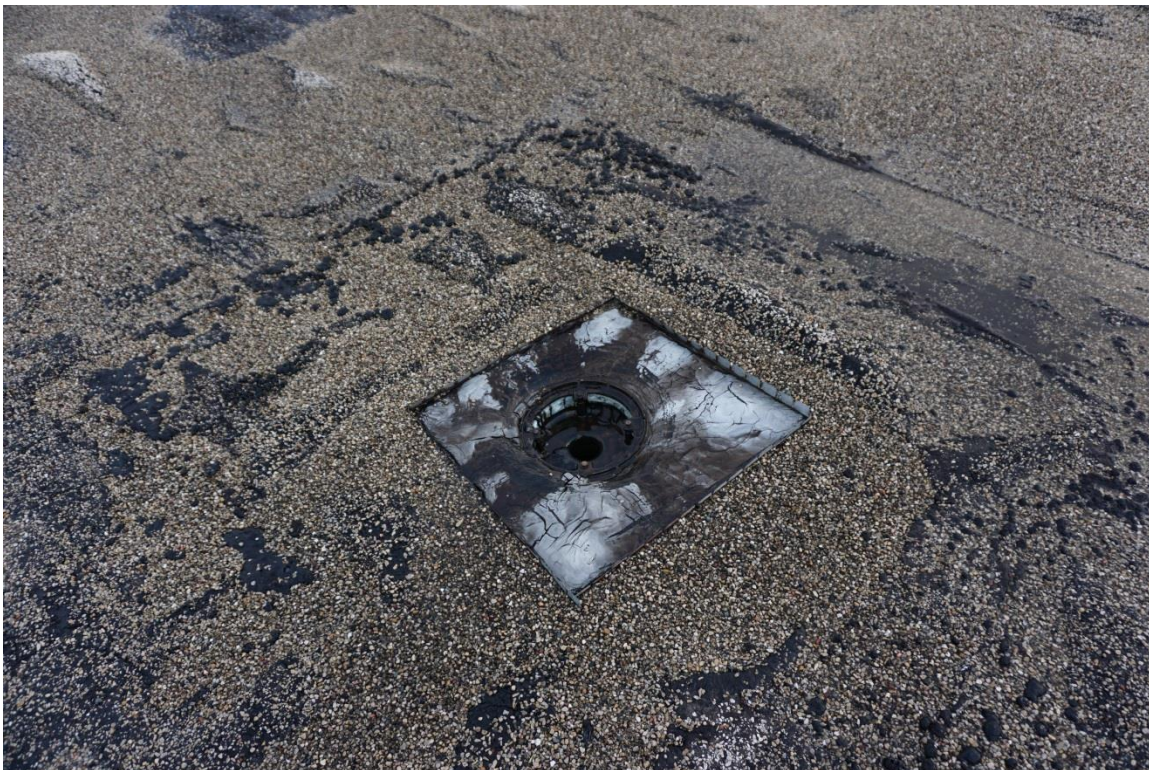
Figure 14: Missing drain cover.

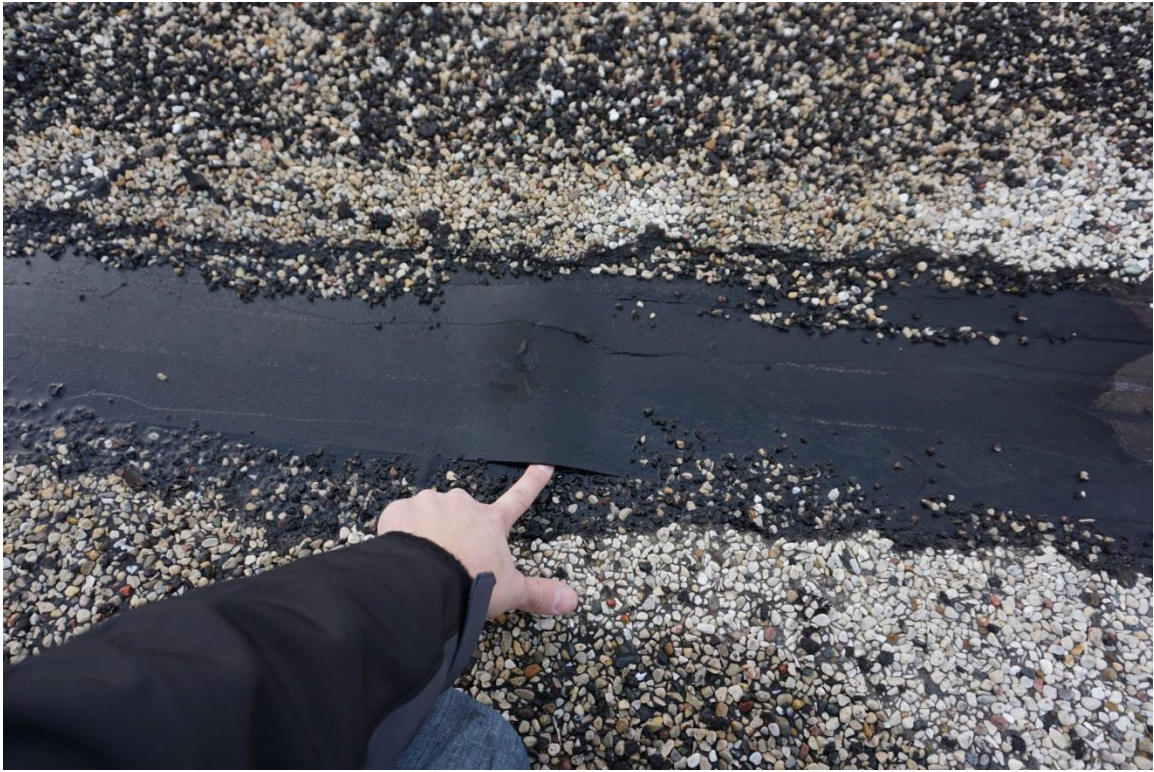
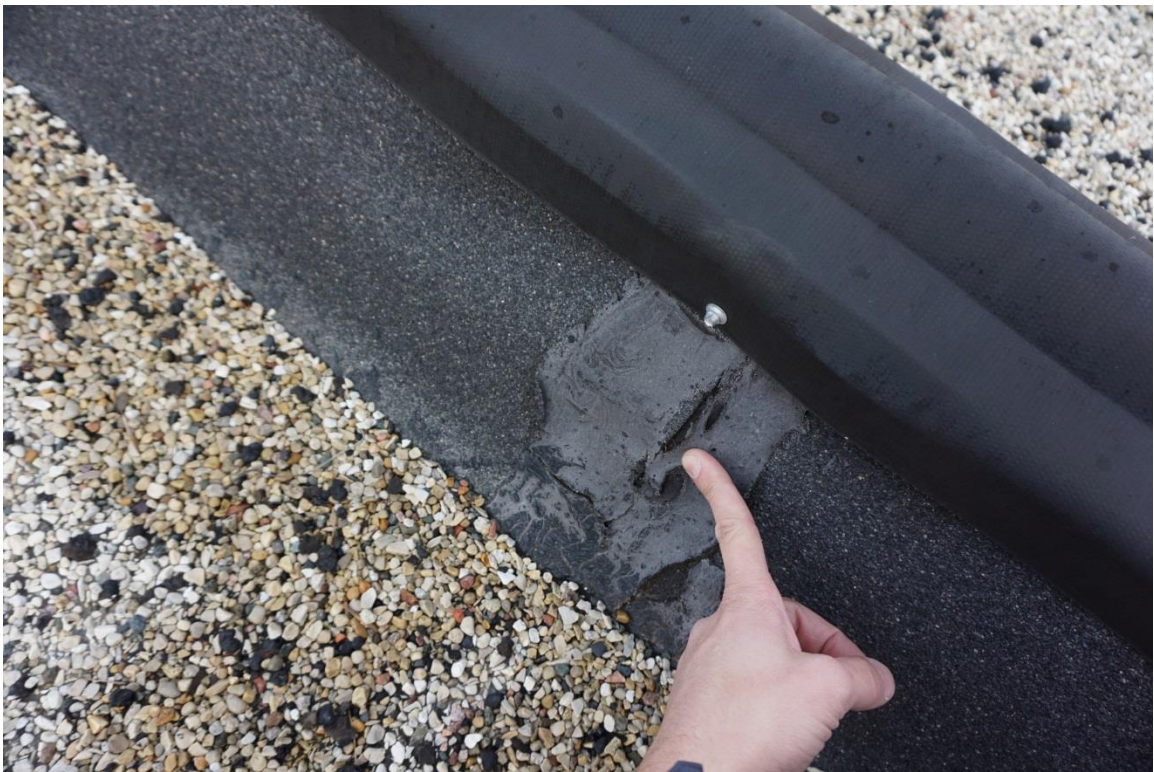
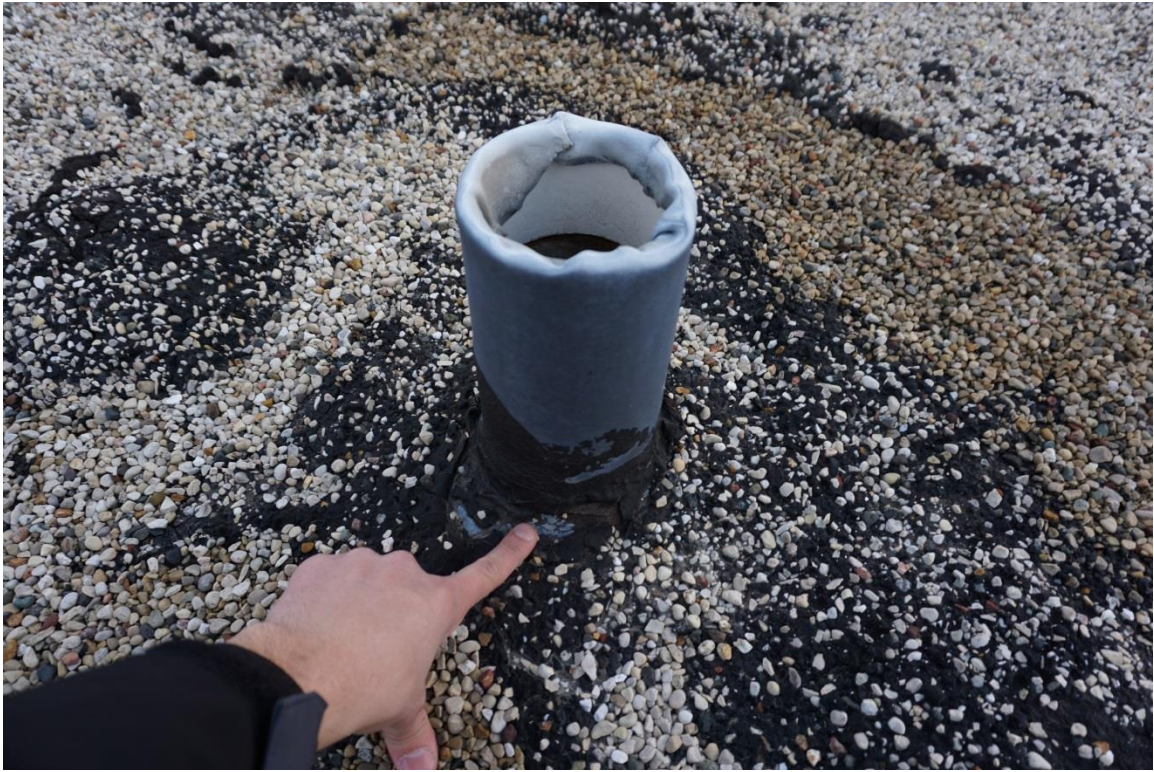
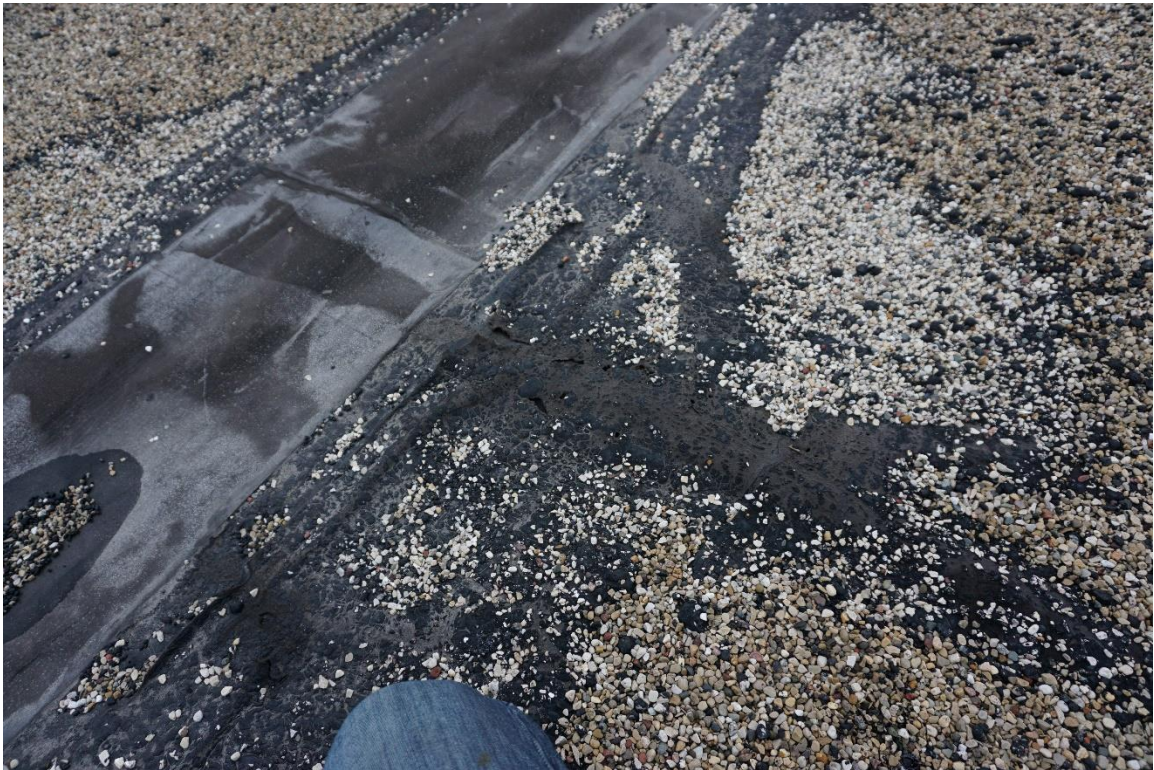
Figure 15: Punctures/failures in roof system.

Figure 16: Punctures/failures in roof system.

Figure 17: Punctures/failures in roof system.

Figure 18: Punctures/failures in roof system.
